Diagnosis and Mitigation of Ground Noise Pollution

Power Quality @ Variable Frequency Drives

By Rajen MEHTA / Kartik PAREKH

**Presented at PQSynergy International
Conference 2015**

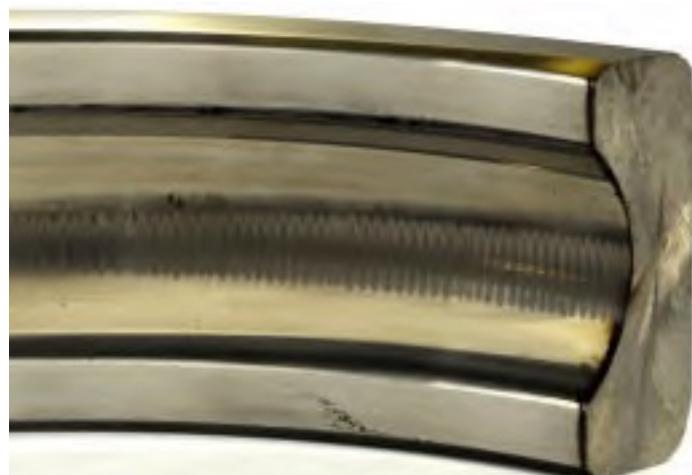
Three phase symmetry challenges in VFD driven loads...contd.

- High Voltage noise signals $> 8 \text{ V}$ can overcome the insulating properties of bearing grease, and the resulting sparks can cause pitting, fluting and fusion craters, eventually, premature failure of the bearings and motor.

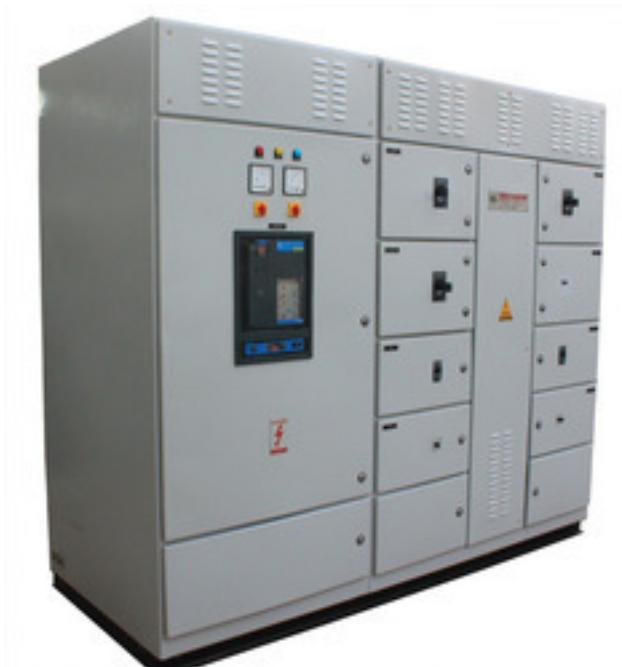
Feeder #1

- Winder Transformer
- LT Mains Incomer
(Star winding)

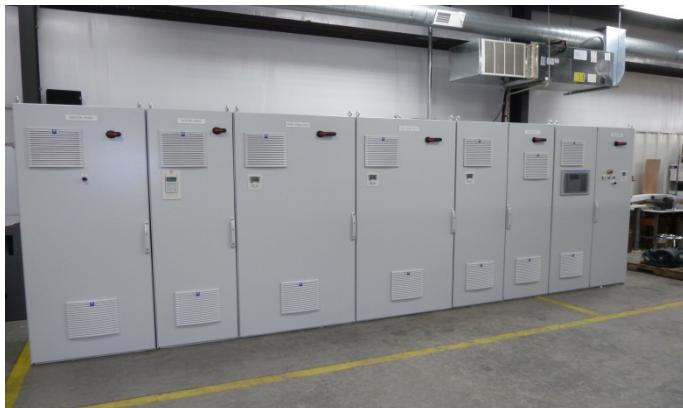
Feeder #2

- Winder VFD Panel
- Sub-mains Incomer
(Input side of VFD)

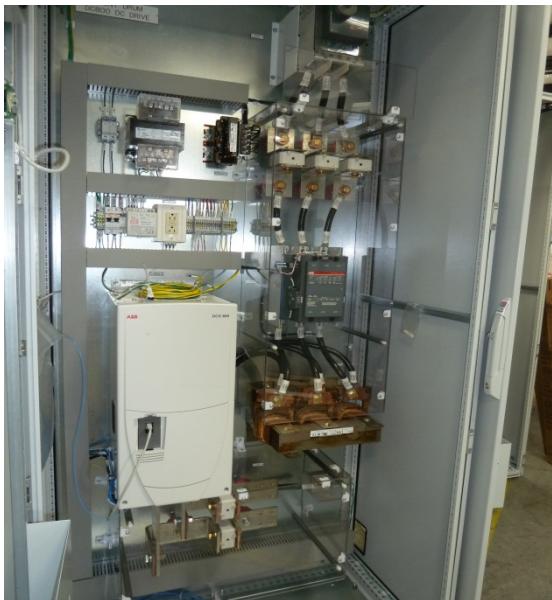
Feeder #3

- Slitter VF Drive
- Output Mains

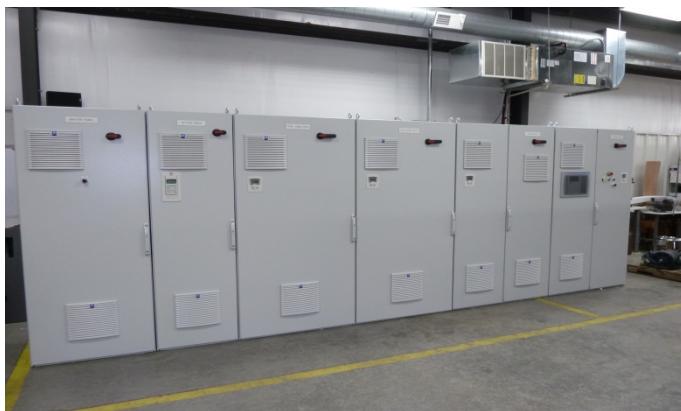
Feeder #2

- Winder VF Drive Panel
- Sub-mains Incomer

- V-THD: 20%-30%
(3ph-Earth)
- Predominant
Harmonics: 2, 5, 7
- Neutral to Earth
Voltage: 2.5V < 6.9V

- V-THD: **70% <85%**
(3ph-Earth)
- Predominant Level of
Harmonics: 2, 5, 7
- Neutral to Earth
Voltage: 2.5V to **30V**

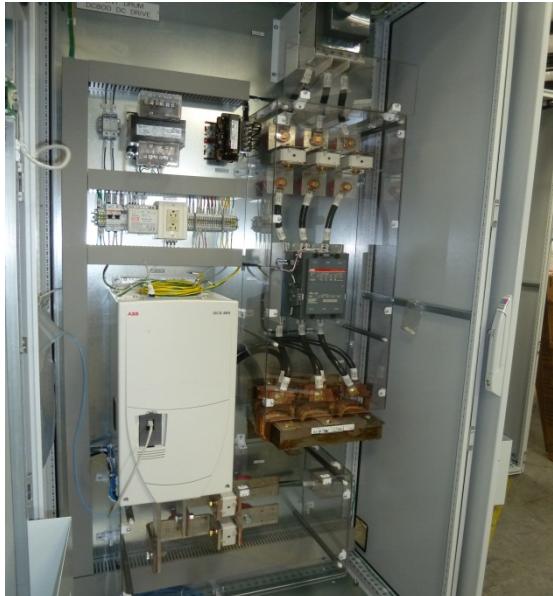
Feeder #3

- Slitter VFD
- Output Mains

- V-THD: 15% < 35% (with earth reference)
- V-THD: 10% < 30% (without earth reference)
- Crest Factor: <5
- Predominant Harmonics: 2nd (with & without earth reference)
- Voltage peak: **25V**, when RMS is **19V**.

- V-THD: 98.5% < 101% (with earth reference)
- V-THD: 37% < 62% (without earth reference)
- Crest Factor: > 20
- Predominant Harmonics: 2nd (with & without earth reference)
- Voltage peak: **377V**, when RMS is **19V**.
